Rehabbed Concrete on Coolidge Dam: Nine Years and Still Holding

By Lori R. Huffman, JPCL-PCE

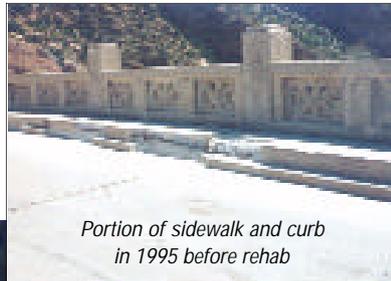
Portion of sidewalk and curb in 1995 before rehab

According to Johnson, the damaged areas of the concrete curbs were saw-cut, chiseled out, pressure washed with salt removal solution, and replaced with epoxy-bonded concrete. The concrete surface was pressure washed with a 1:100 dilution of the liquid soluble

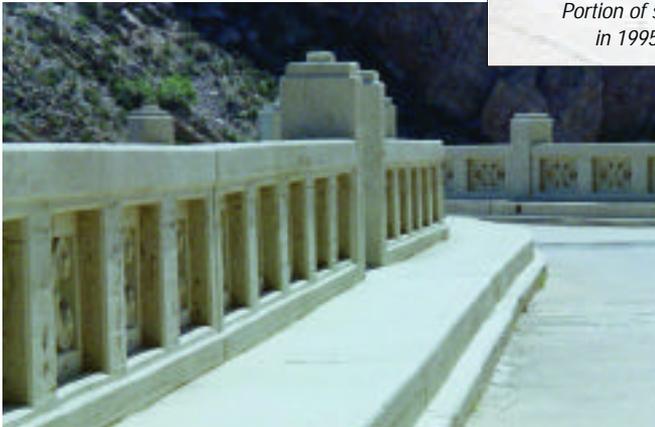
Curb and walkway on both sides of road 9 years after rehab

When Johnson examined the curbs and pylons in September 2004, he was pleased with their appearance. He gave particular attention to the horizontal portions of the walkways on either side of the roadway and the "bird bath areas" where water tends to pool. According to Johnson, the concrete patching on the curbs was sound. Johnson's main concern for the pylons was the possibility of re-cracking due to rebar corrosion; however, inspection revealed that the structures remained sound. Johnson was able to find only two small areas of the pylons that had cracked, one measuring about four inches and the other measuring approximately six inches.

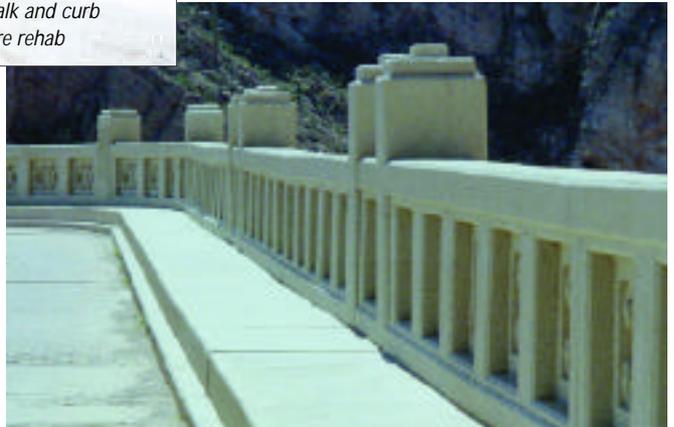
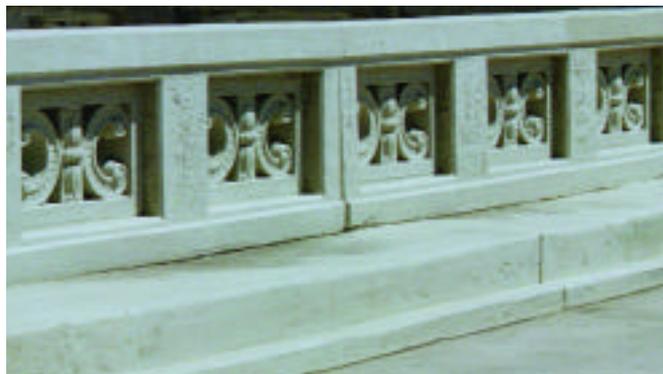
This sidewalk area has had puddled standing water since being repaired and recoated but the coating remains intact
Photos courtesy of Chlor*Rid

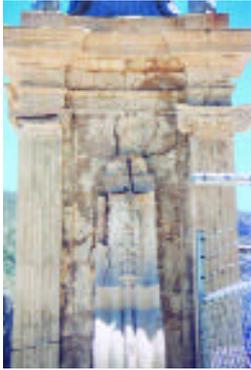
found to have accelerated the corrosion of the rebar, of particular concern for the pylons, which exhibited severe cracking. (See "Coatings on Dam Intact 4 Years after Rehab, Salt Removal,

Top: Pylon before rehabilitation in 1995. Center and bottom: Pylon in September 2004. There is minor rust staining from the fixture above. Completely intact as completed in 1995 with some small rust stain bleeding from above.

The contractor used the same dilution of liquid soluble salt remover and pressure washed the cracks in the pylons at 3,000 psi. Johnson determined the amount of time needed for

cleaning based on the length of the crack. The requisite time worked out to 10 to 15 minutes per linear foot, he says. The workers held the pressure washing nozzles directly on the cracks and as close to the surface as possible while cleaning. Johnson estimates that approximately 600 linear feet of cracks were cleaned. After cleaning, the con-

tractor filled the cracks with a 100% solids epoxy that was injected through a system of ports located from the bottom to the top of each crack.

Delicate fill work had been performed on the pylons. The damaged scroll and crest pieces of these structures were also reconstructed. Once this work was complete, the pylons were also pressure washed to remove chlorides before painting with the same elastomeric coating.
