Coatings on Dam Intact 4 Years after Rehab, Salt Removal, Repainting

by Jim Johnson, Chlor*Rid

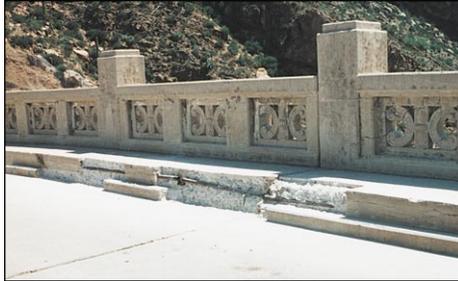
Deteriorated concrete curbs have been chiseled and cut out before repair, cleaning, and coating.

For repair of the curbs, each saw cut was to meet at the corner, but no overlap of cuts was allowed. The concrete within the sawcut area was to be chiseled out, the area formed, and new epoxy-bonded concrete placed. The decision was made to use handmade wooden forms of plywood and dimension lumber.

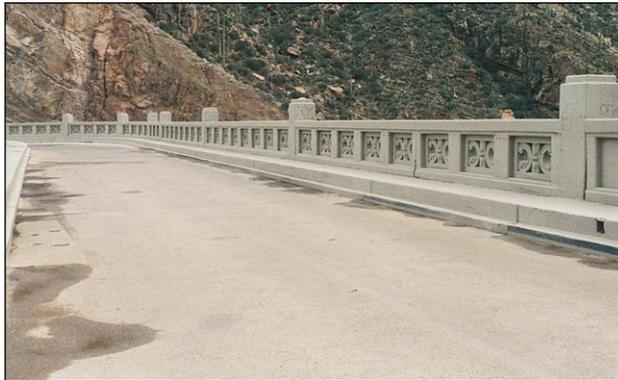
Concrete curbs four years after repairs, cleaning with soluble salt remover, preparing, and coating. Wet areas have puddled repeatedly from weather but the coating remains intact.

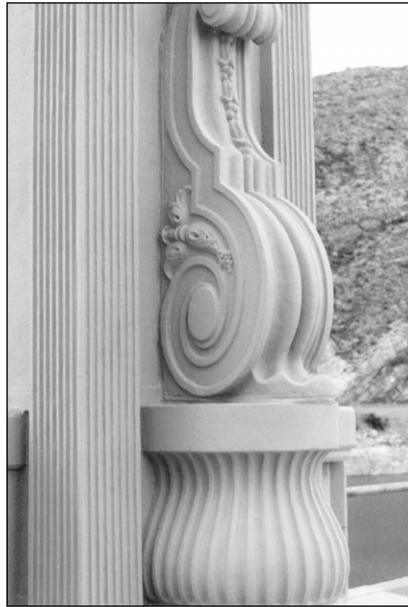
The most complicated portion of the work was on the four pylons. They required not only functional repair and reconstruction, but also major improvements to their appearance. The contractor recognized that the cracking resulted from the rebar corrosion, which was due to chloride contamination. The BoR had no established specifications to deal with chloride contamination. Unchecked chloride contamination would lead to more corrosion and the reappearance of cracks. Although no data were available on how the liquid soluble salt remover would perform in removing the chlorides from a crack when thoroughly washed with a pressure washer, the BoR approved the treatment method for the pylons. The contractor mixed the liquid soluble salt remover in a 1:100 dilution and used a 3,000-psi (20 MPa, gasoline-powered pressure washer. Workers washed the cracks, spending approximately 10 to 15 minutes on each linear foot of crack. They held the nozzles directly to the crack and as close to the surface as possible. The specification called for the pylons to be painted after the repairs, so the entire surface of the pylon was washed during the operation to remove soluble salts. Soluble salt testing using patch tests or swab tests could not be performed for two reasons: the extremely rough texture

Left: Cracks permeate the concrete pylon before rehabilitation work.

After both the cracks and the surface of the pylons were sufficiently decontaminated, the cracks were injected with epoxy. A port was affixed every 6 in. (15 cm) with a 100% solids epoxy adhesive. The crack between each port was covered with an epoxy paste made from the same adhesive but blended to a mortar consistency with 60-grit aggregate. Workers also injected the 100% solids epoxy into the ports, starting from the bottom. Pressure was applied on the epoxy injection until the epoxy came out of the port above. Then, the port being injected was plugged, and the injection gun was raised to the next port. In that manner, each crack was filled to the top. The next day, workers removed

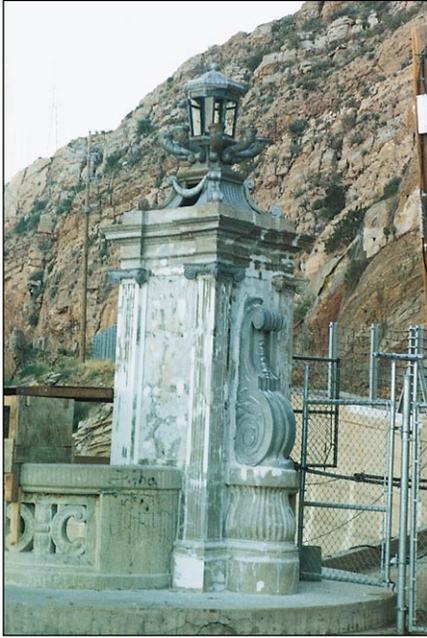
Pylon with plaque before any repairs were undertaken

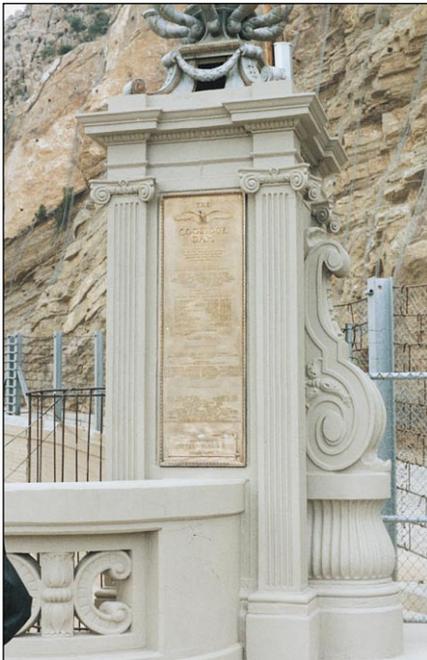
Pylon and plaque four years after repairing, cleaning, including soluble salt removal, and coating
