CASE STUDY

# Premature Failure of Repainted Epoxy on the Internal Bottom Plate of a Fuel Oil Tank

M. MOBIN AND A.U. MALIK, *Saline Water Conversion Corp.*

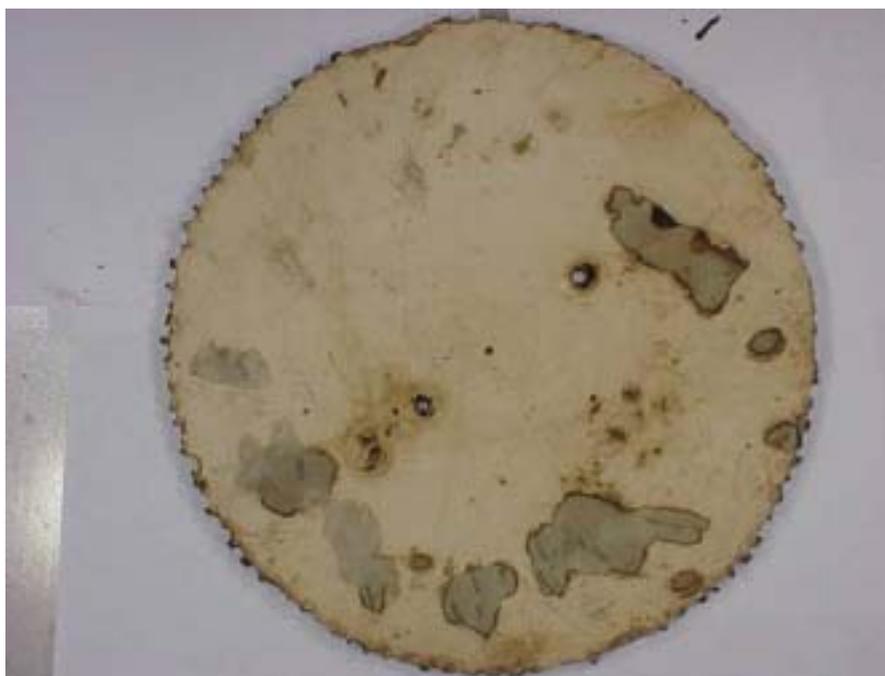
**FIGURE 1**

Figures 1 and 2 show the bottom plate sample in the as-received condition. A visual examination of the plate showed two holes with cavities (the average depth and diameter of the cavities were ~5.1 and 15.0 mm, respectively), in addition to some pits on the inner surface (working side) of the plate. Figure 3 provides a closer view of the plate and shows the large perforations.

Interior surface of bottom plate sample in the as-received condition.

1) The cavities and minute pits already present on the inner side of the bottom plate of the tank were caused by local corrosion that stemmed from the failure of the original epoxy coating from its long exposure to crude oil.

2) The surface pits should be repaired before applying the coating.

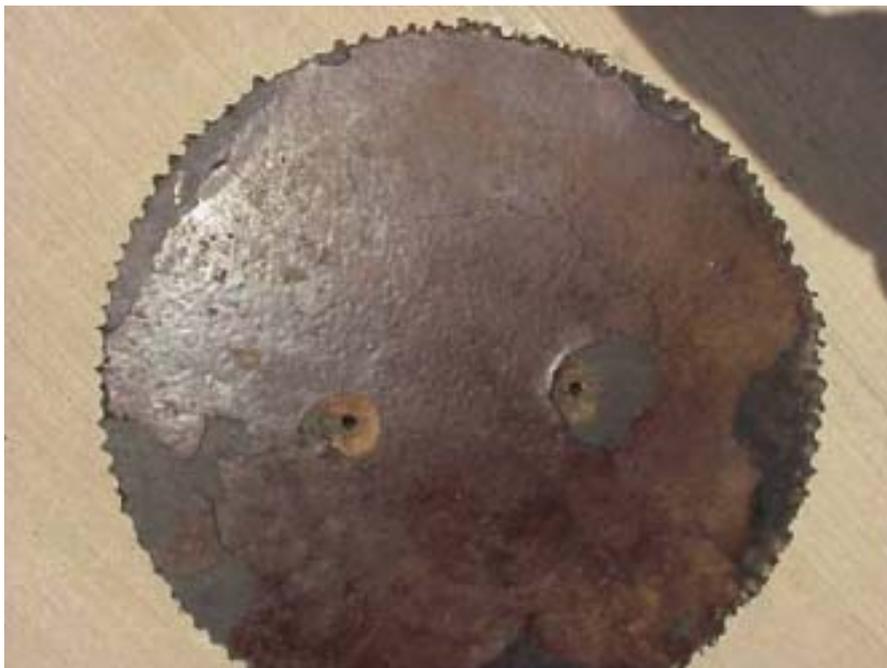
**FIGURE 2**

External surface of bottom plate sample in the as-received condition.

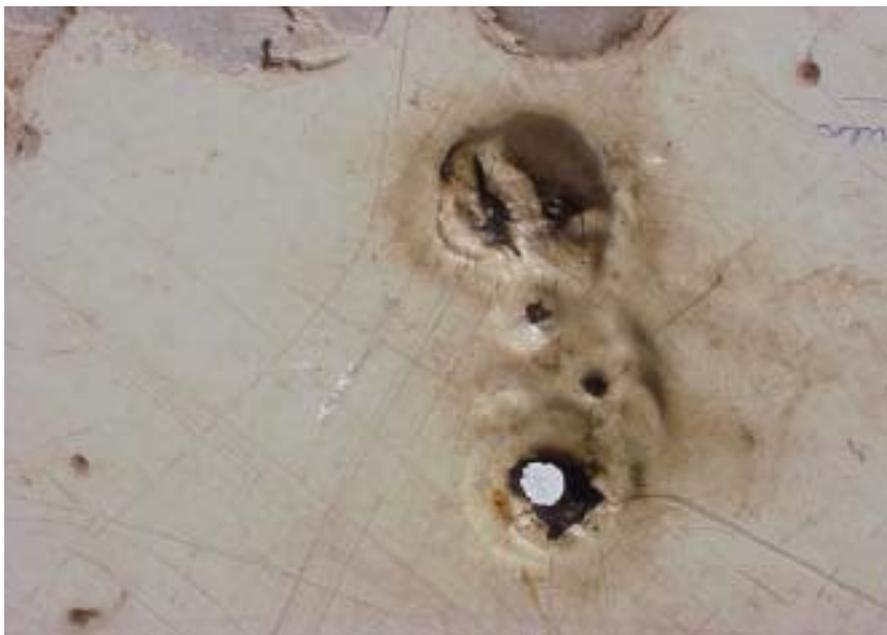
**FIGURE 3**

Close-up view of the hole in the existing cavity.

The EDX profile of the corrosion products at the surface of the pit beneath the epoxy lining shows strong peaks of Cl, Si, Fe, O, Al, Mg, S, P, K, Ca, and Ti, suggesting the presence of a significant amount of chloride contamination and other impurities in the corrosion product that remained in the pits prior to the application of the coating. The chloride in contact with steel forms ferrous chloride ( $FeCl_2 \cdot 4H_2O$ ), which in the presence of air further oxidized to  $FeCl_3$ .  $FeCl_3$ , being a hygroscopic salt, drew in moisture, creating a concentrated  $FeCl_3$  solution on the steel surface. The repainted epoxy coating failed prematurely as iron salt drew water through the coating by osmosis and created an area of poor adhesion and blistering. The epoxy coating applied over the existing cavities further contributed to the premature failure of that coating. After failure of the epoxy coating at the existing cavities, an ideal site for pitting corrosion was created. The corrosion proceeded at an accelerated rate and ultimately led to the perforation of the remaining plate thickness in ~2 months.

1) To avoid premature failure of such coatings, chloride decontamination should be considered as an essential step after sandblasting. The chloride decontamination may be achieved by phosphoric acid treatment through which insoluble iron phosphate ( $\text{FePO}_4 \cdot 2\text{H}_2\text{O}$ ) is formed rather than  $\text{FeCl}_3$ .

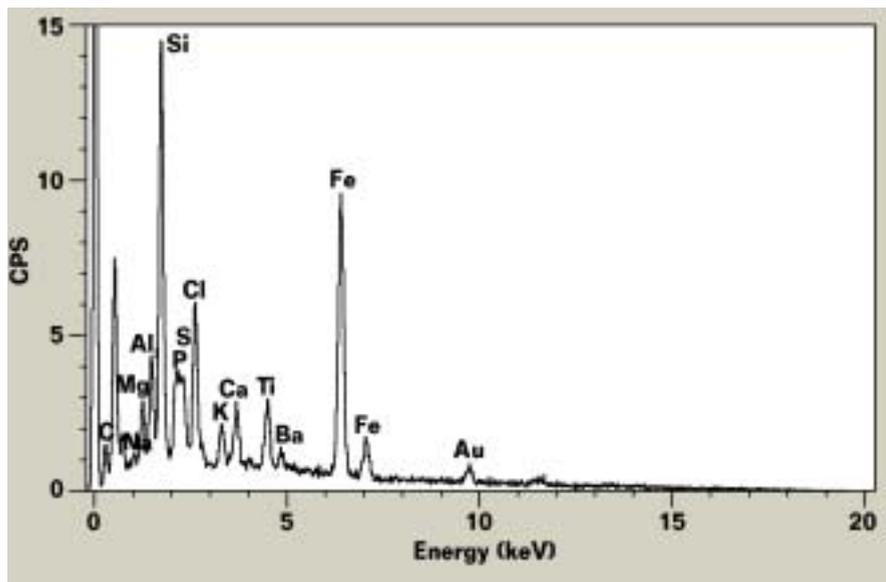
**FIGURE 4**

Table 2 lists the chemical composition of the plate material as analyzed by the ICP technique and C and S analyzer. The chemical composition matches the specified composition of the plate material ASTM A36, a carbon steel. The EDX studies of the corrosion products on the surface of the pit, beneath the epoxy lining, show strong peaks of Cl, Si, Fe, O, Al, Mg, S, P, K, Ca, and Ti (Figure 4). This result suggests the presence of chloride contamination and other impurities, which remained on the pitted surface in significant amounts prior to the application of the coating.

EDX profile of corrosion products collected from the surface of the pits beneath the epoxy lining on the plate.
