BANTLEMAN CONSULTING SERVICE INC.
Anthony Bantleman
Certified NACE International Coating Inspector

Re: Lighthouse Coatings

For your information, attached are photos of four repainted cast iron light towers. Canadian Coast Guard, Newfoundland Division undertook the work

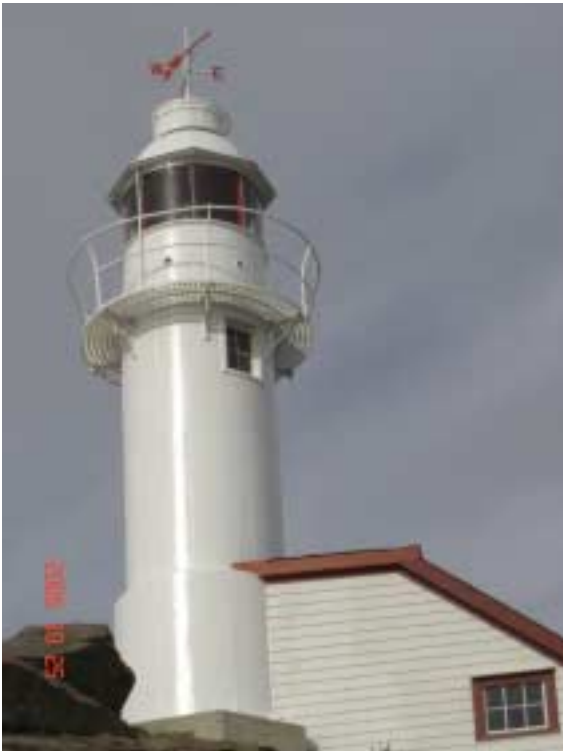
Photo #1: Lobster Cove Head Light Tower, est. 1897, cast iron tower. Rocky Harbour, NL.

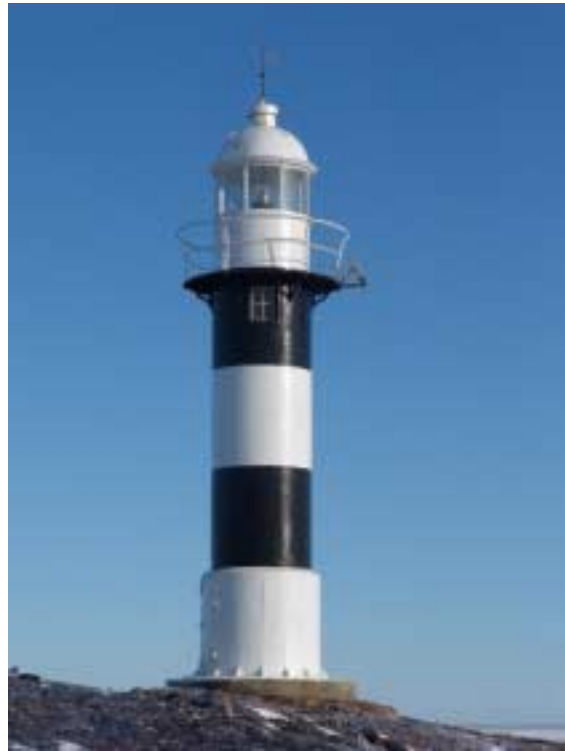
Photo #2: Double Island Light Tower, est. 1905, cast iron tower. Off Battle Harbour, Labrador.

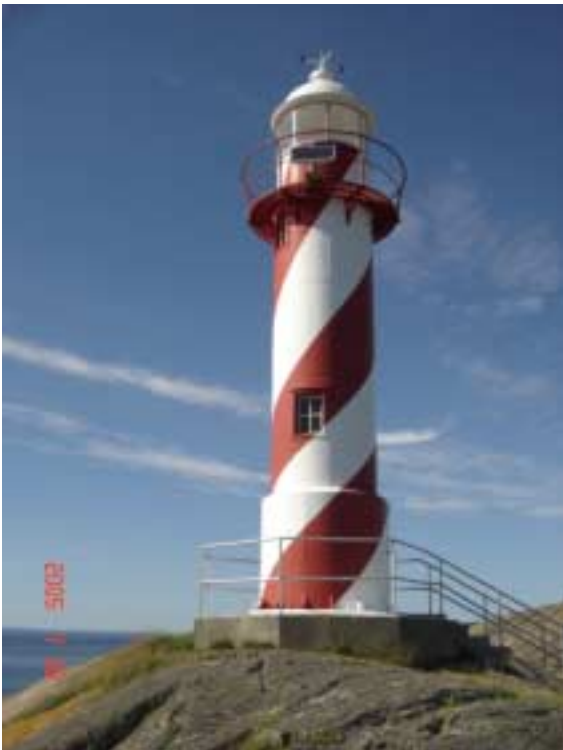
Photo #3: Hearts Content Light Tower, est. 1901, cast iron tower, Hearts Content, Trinity Bay, NL.

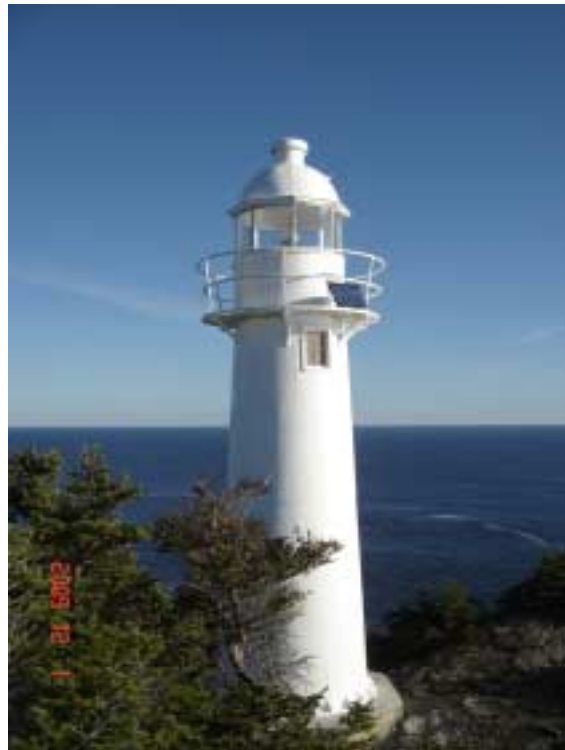
Photo #4: Bull Head Light Tower, est. 1908, cast iron tower, Bay Bulls, NL.
