Museum Makes USS Yorktown Shipshape

By Lori R. Huffman, JPCL

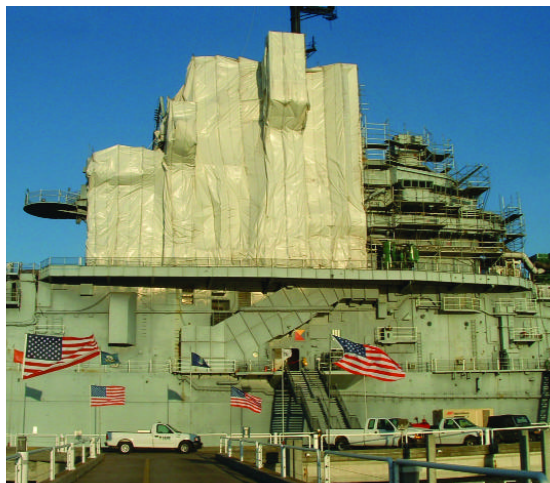
Complex containment for renovating and preserving the Yorktown. Photos courtesy of S&ME Inc.

A subcontractor to the coatings contractor erected the tube and clamp scaffolding and the containment, which

used impenetrable tarping. The contractor used a 40,000 cfm dust collector to provide ventilation during abrasive blasting.
