Making History: Recoating a World War II Aircraft Carrier

Recoat the hull of a World War II aircraft carrier called the *USS Yorktown* in South Carolina

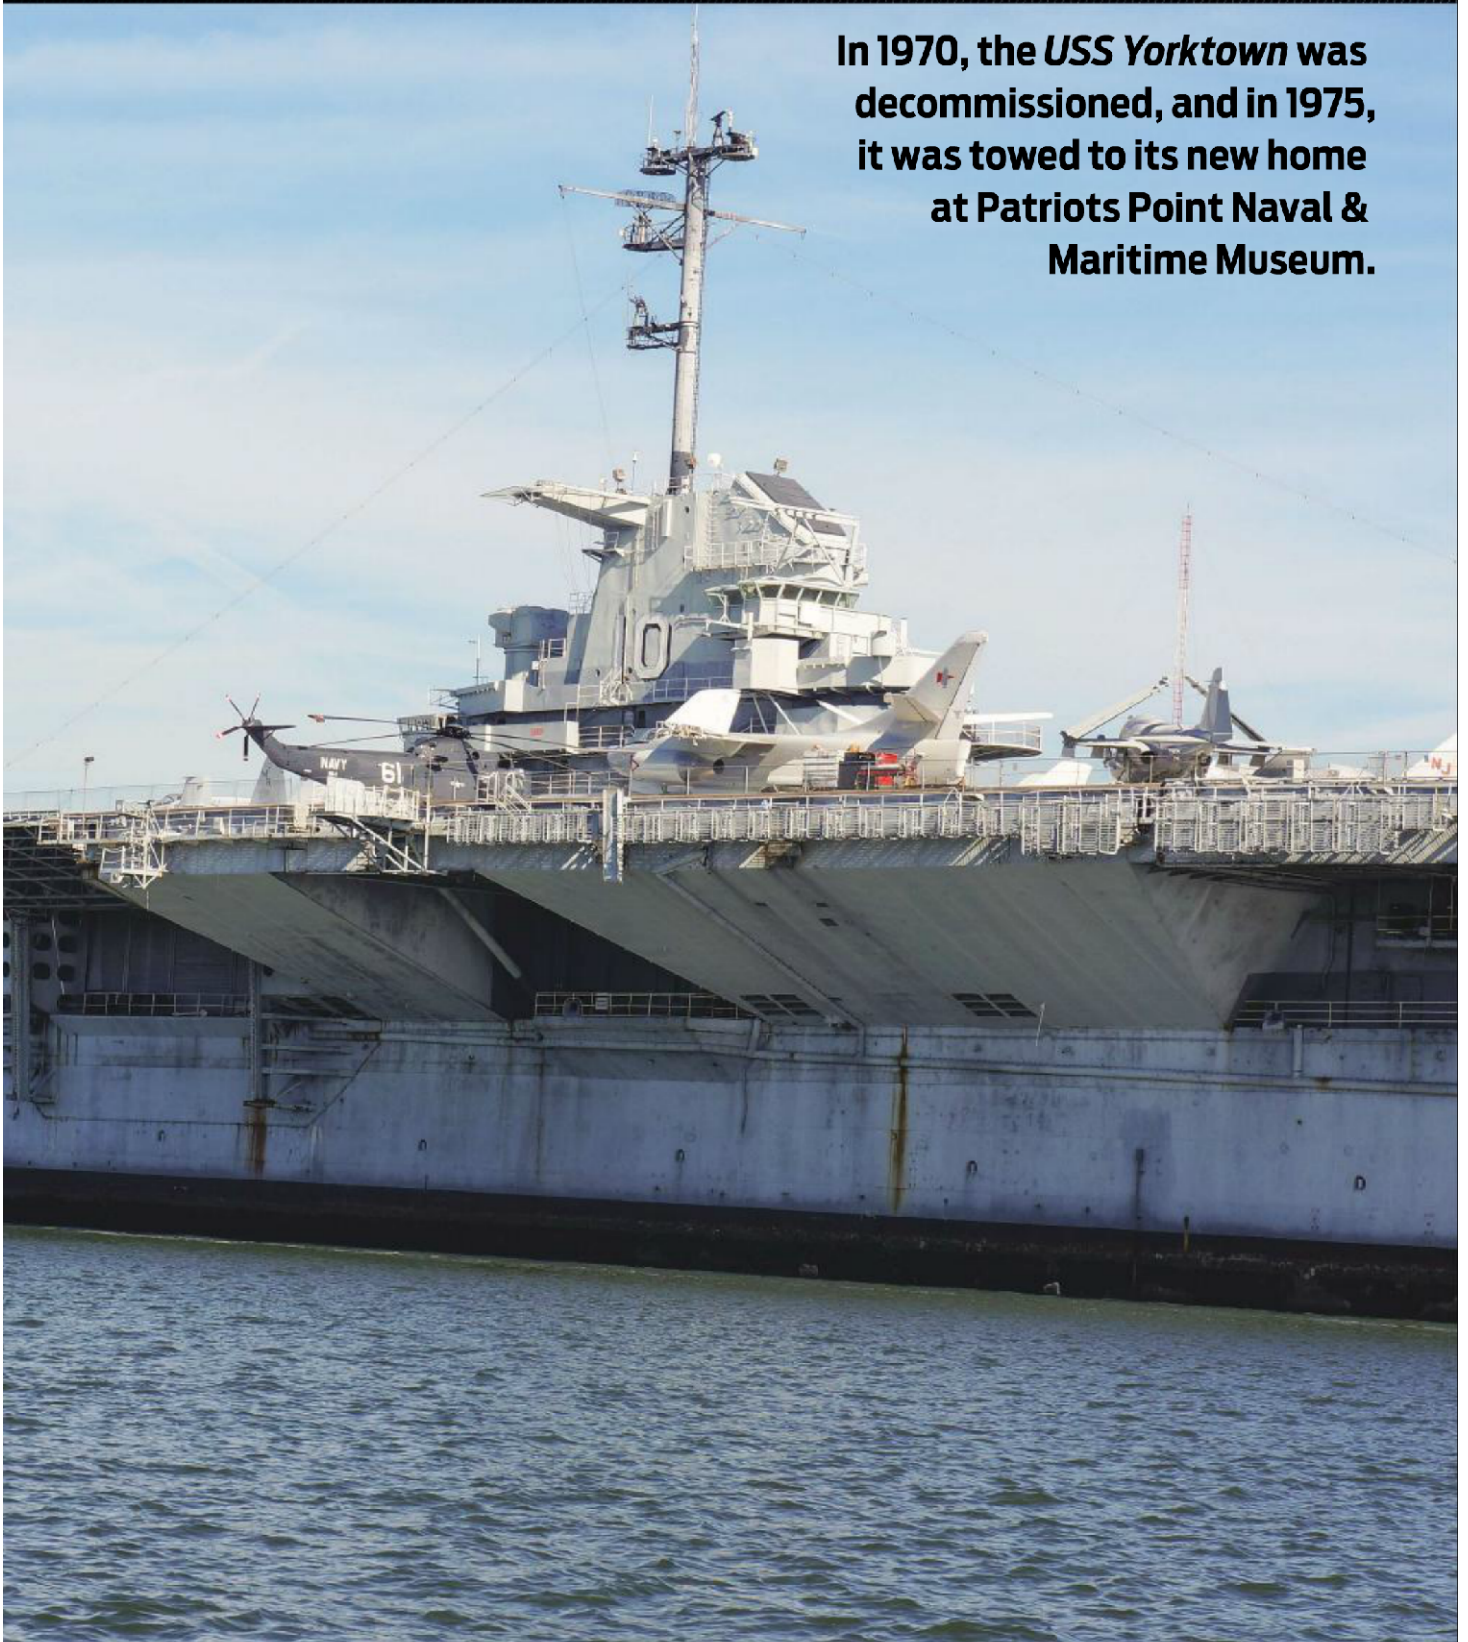
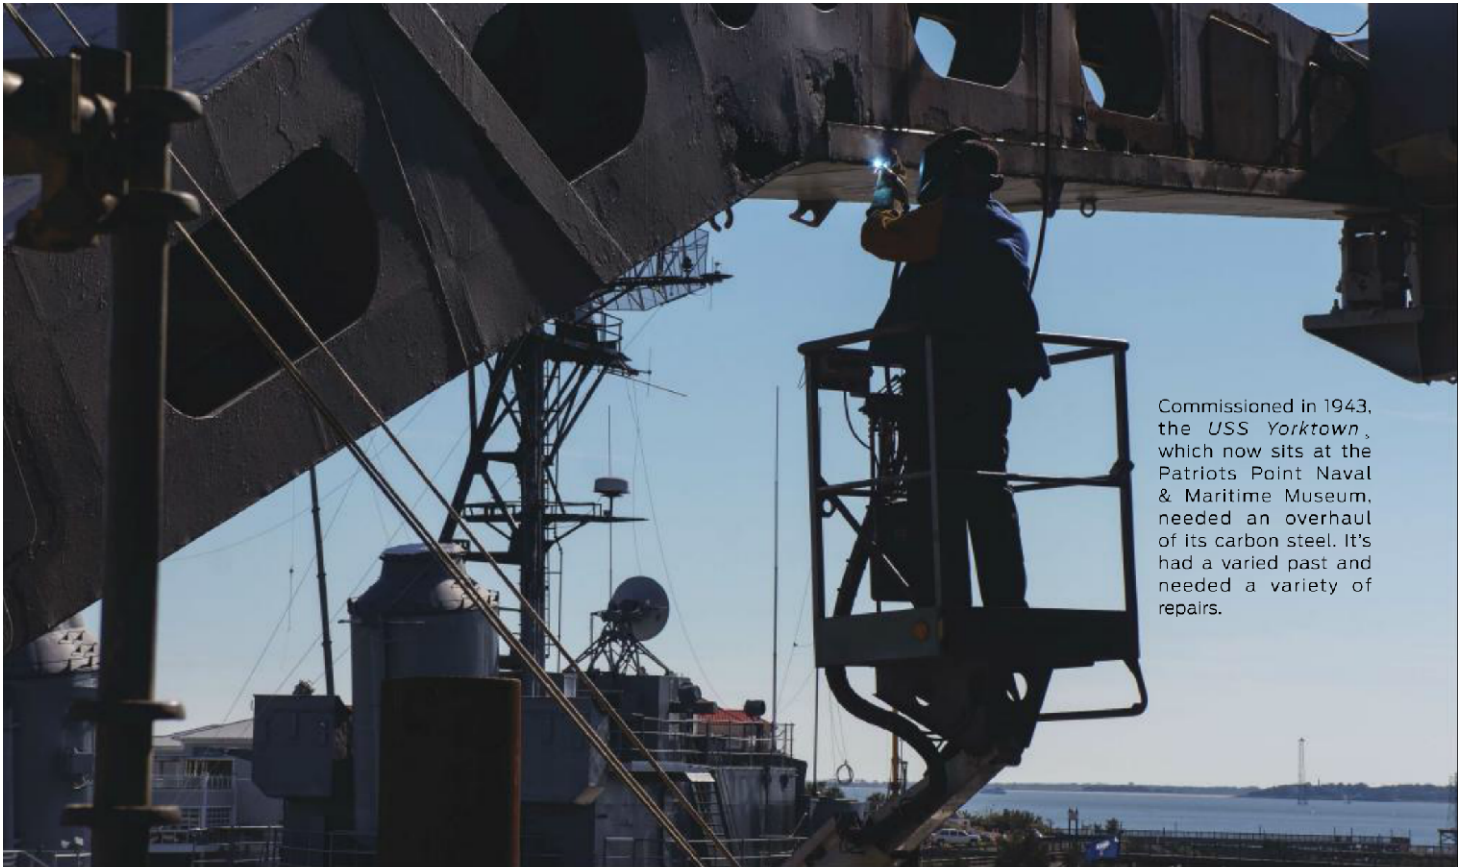
In 1970, the *USS Yorktown* was decommissioned, and in 1975, it was towed to its new home at Patriots Point Naval & Maritime Museum.

Commissioned in 1943, the *USS Yorktown*, which now sits at the Patriots Point Naval & Maritime Museum, needed an overhaul of its carbon steel. It's had a varied past and needed a variety of repairs.

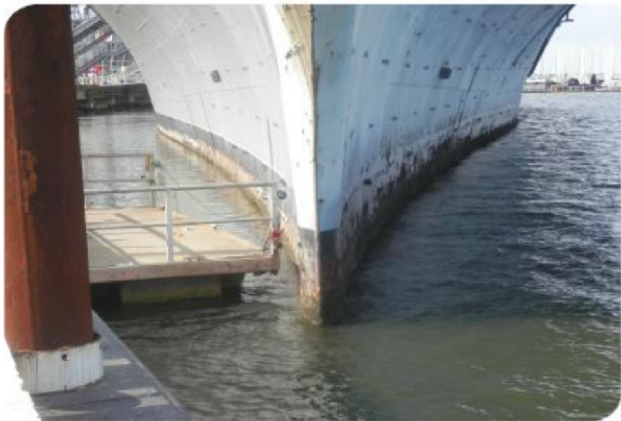
Because the recoating of the hull was to be completed over water, the museum's crew first needed to figure out how to adhere to environmental regulations for removing the old and applying the new coatings.

The crew started by scraping off the many old layers, flakes, and blisters, of paint using a dull paint scraper. The two- to four-person crew carefully collected and disposed of the waste.

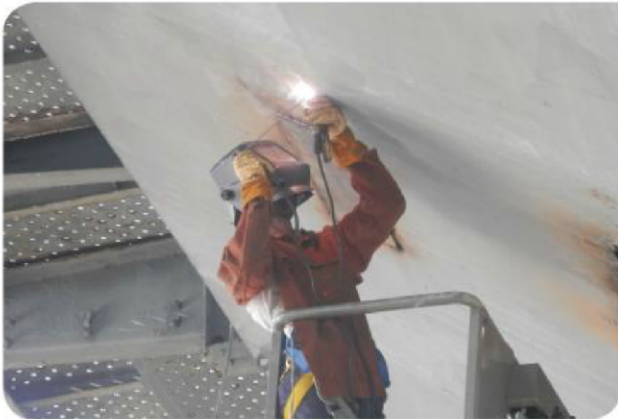
The crew worked from a barge with a 2-ton (1.8 metric tons) man lift. Even with the lift, getting access to all of the nooks and crannies on an angled surface has been a challenge.

The crew started at the bow of the ship and began working down the starboard side. They use a barge with a 2-ton (1.8 metric tons) Nifty TM50 man lift, which allows the workers to be able to reach up on the side of the ship that they need to do their work. Once they are finished with the starboard side, they will bring the barge back to the front and do the port side. The crew uses tarps draped between the *Yorktown* and the barge to make sure none of the chips of paint they scrape off land in the water. When they are done, they will have resurfaced 50,000 square feet (4,645 m²) of carbon steel.

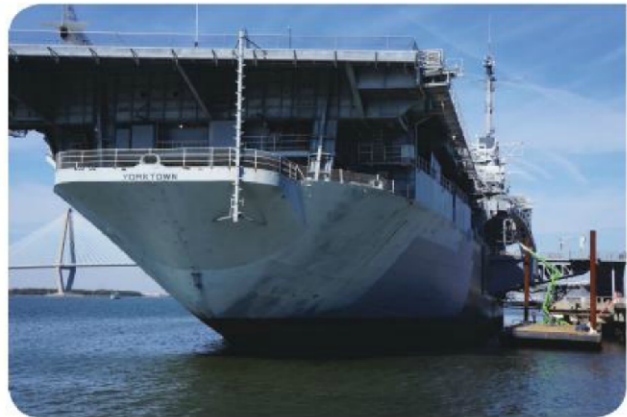
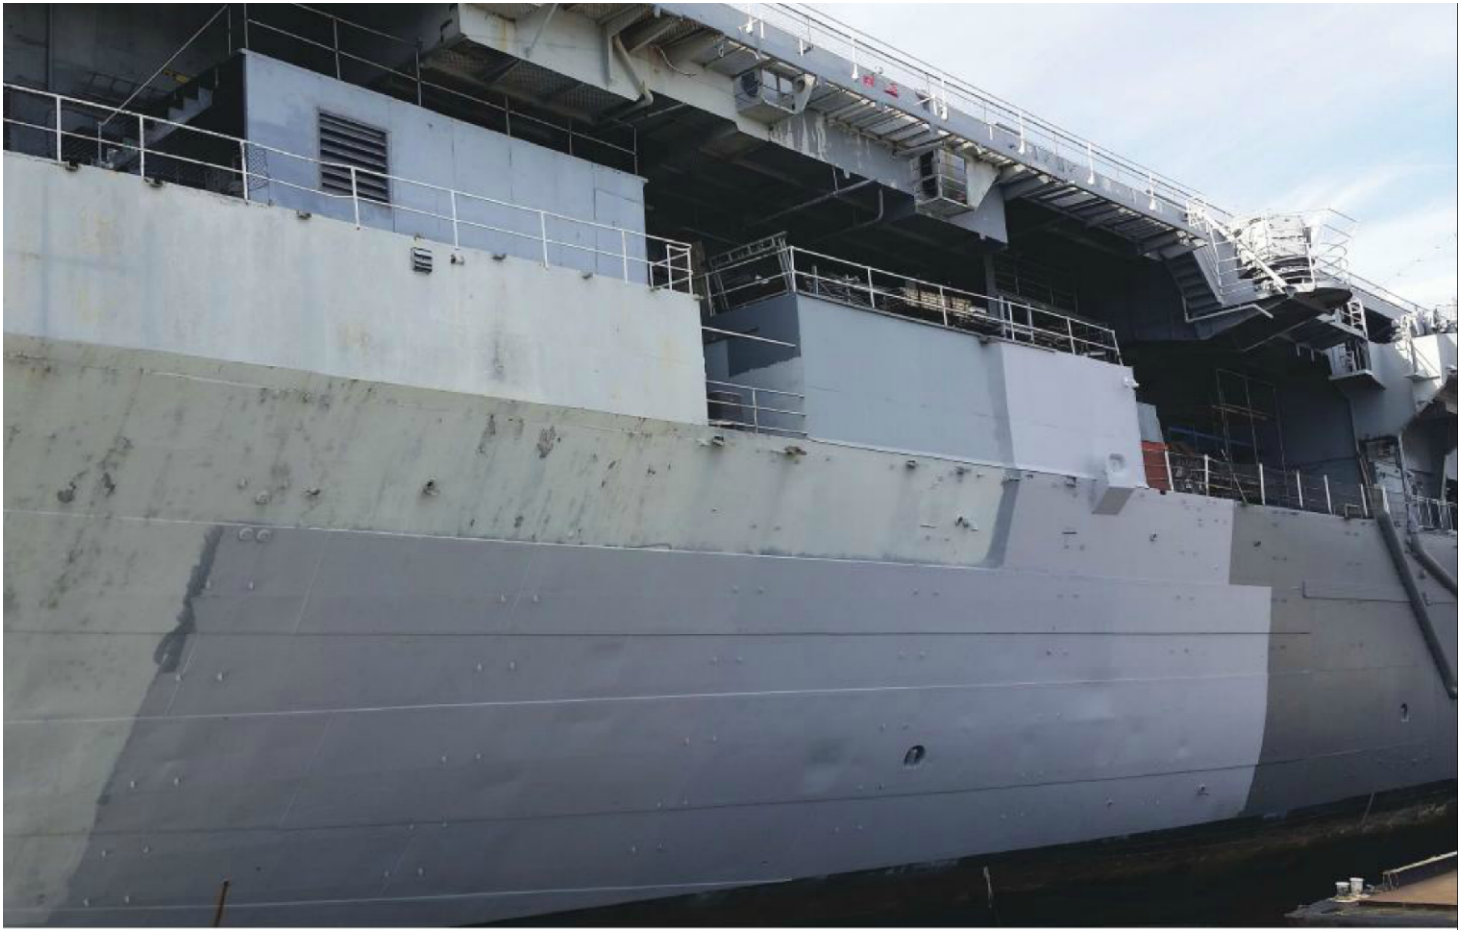
Before the coatings could be applied, the crew needed to prep the steel hull. This included cleaning with CHLOR*RID and a pressure washer to help remove the salts on the side of the ship.

The first of two coatings was the primer, which was applied at of 2–4 mils (51–102 microns) wet film thickness (WFT) from the ship's bow, down the starboard, and to the port.

The crew has been relying on a specific product called CHLOR*RID to get the job done. Howard said the crew cleans the ship with a very low pressure wash of CHLOR*RID solution, which helps remove the salt from the side of the ship.

Howard said the CHLOR*RID has been working well to help clean the substrate. After the surface is as clean as the crew can get it, the crew applies ROC Prime 100, a primer from Rust-Oleum, at an average wet film thickness (WFT) of 2 to 4 mils (51–102 microns). They follow that with two coats of Rust-Oleum’s Sierra Performance MetalMax, a water-borne acrylic urethane.

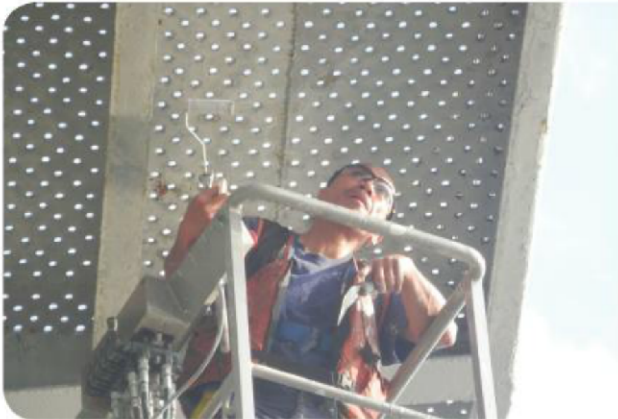
The crew roller-applied two layers of the topcoat to reach a total average WFT of 2–4 mils (51–102 microns). As Bob Howard, the museum's operations director, explained, they couldn't spray due to regulations.

The crew applied the coating in two layers to reach a total average WFT of 2 to 4 mils (51–102 microns) using rollers. “We didn’t spray; we had to apply with rollers because that was part of the process the regulatory agencies said we needed to use,” Howard said.

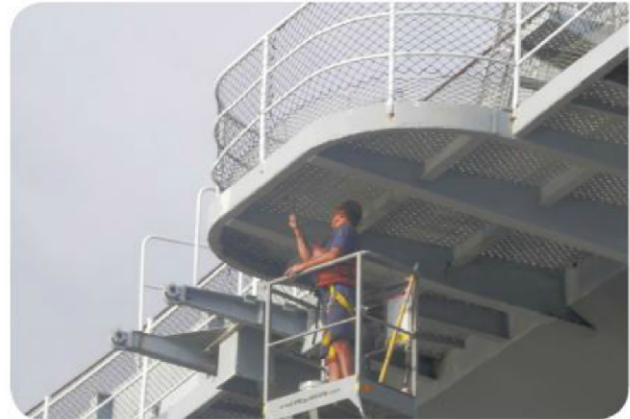
The crew wore harnesses at all times when working over water and on the lift. They also wore face shields, safety goggles, and gloves when necessary, such as during the surface prep.

For safety, the crew wears life jackets and harnesses at all times when they are over water and on the lift, Howard said. All employees were also trained in using the proper personal protective equipment at all times, including face shields and safety goggles during the preparation process and painting, and gloves when needed to avoid skin contact with products being used.
