Coating The Reactivator Tank: A Step Into The Future

BY JOHN BRODAR P.E., OWNER REPRESENTATIVE, AND RANDY CARLISLE, SUPERINTENDENT KEENE COATING
PHOTOS COURTESY OF THE AUTHOR

Sandblasting and coating interior of reactivator tank at NGS

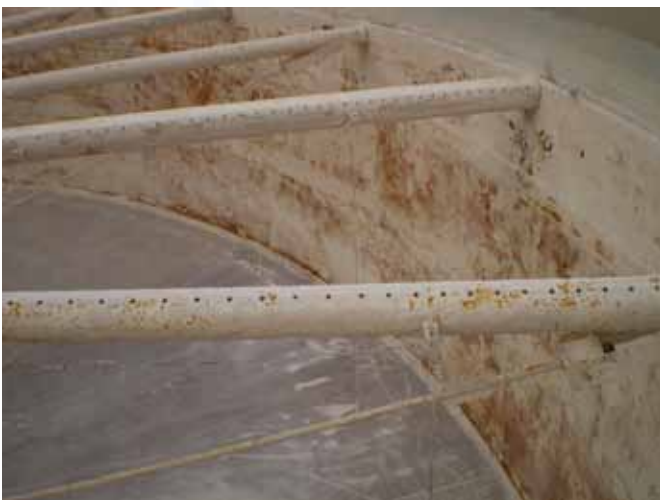
LEFT ◀ When NGS management began looking for unscheduled maintenance projects during a scheduled outage, their attention turned to the pitted and rusted carbon steel Reactivator 2 tank.

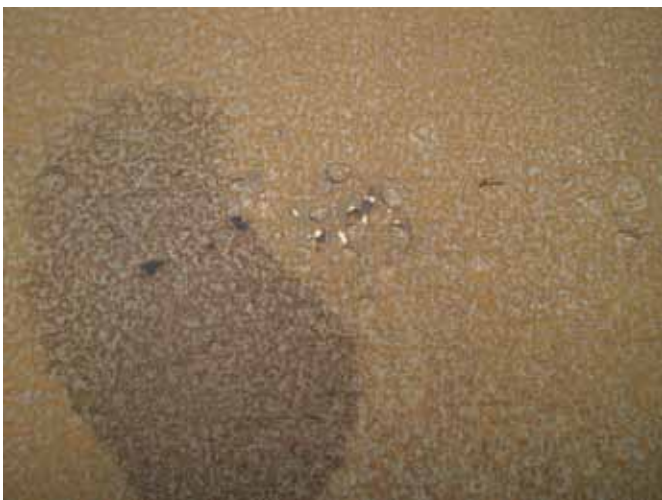
BELOW ▼ The crew blasted the surface to NACE No.2/SSPC SP-10 "Near White Metal Blast" using a water ring on a blast nozzle and adding a mixture of 100:1 Chlor-Rid to the water to create a surface profile and remove chlorides from the carbon steel.

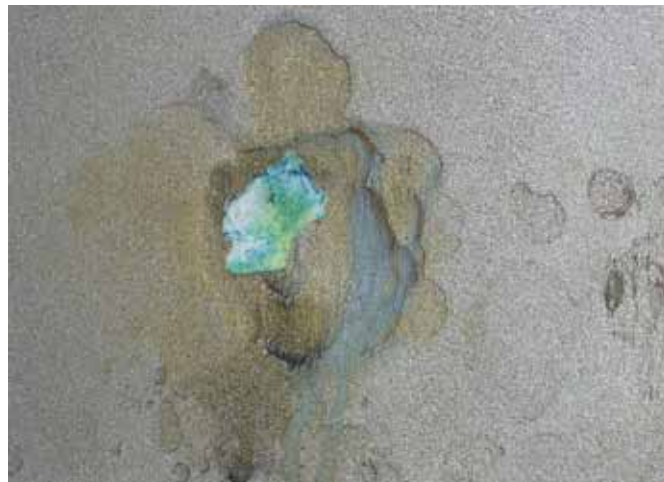
ABOVE ▲ "Then he [Brodar] got some yellow paper and a spray bottle. Every place he sprayed with distilled water and applied the paper changed color from yellow to blue. He explained that it was an indicator of chloride contamination on the steel," says Carlisle.

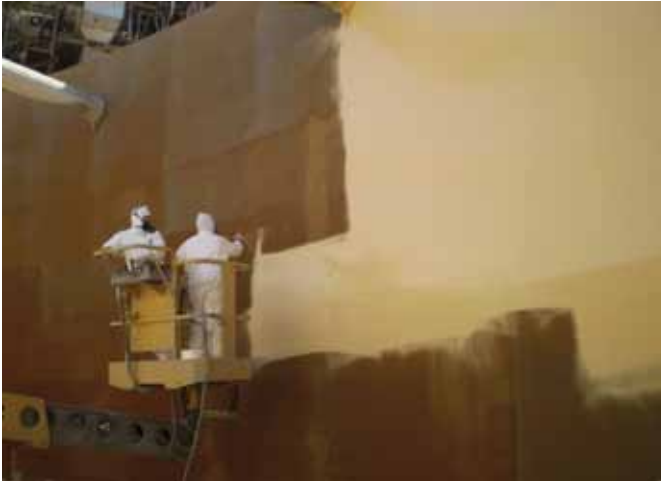
ABOVE ▲ The crew used a Graco 74:1 spray pump to spray-apply the specified two coats of Carboline 235 at 6-8 mils (0.15mm-0.20mm) DFT per coat.

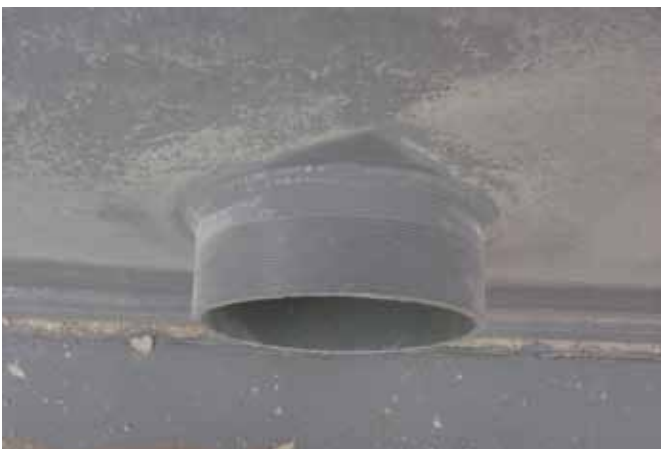
BELOW ▼ After one year of hard service, even the 8" (20.32cm) threaded pipe nipple was rust-free.

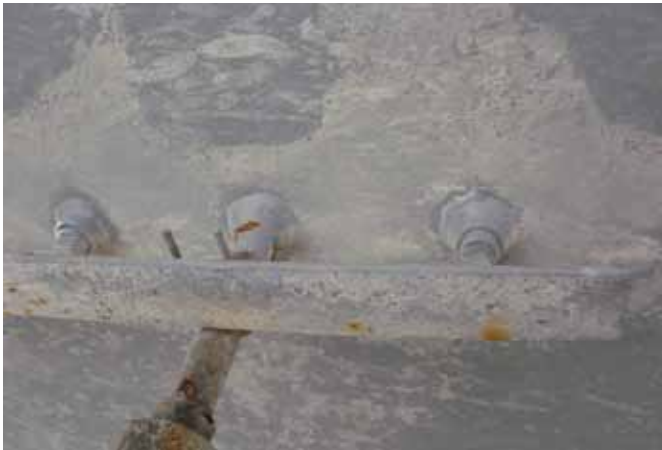
ABOVE ▲ At the year-anniversary inspection, the only rust observed on the carbon steel substrate was observed on this pipe.

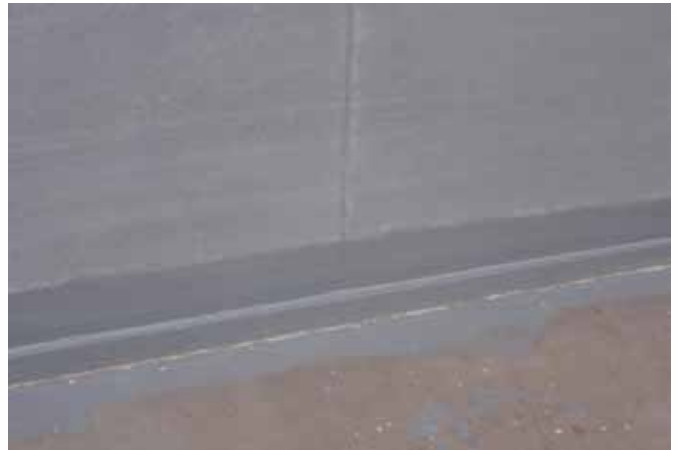
ABOVE ▲ Even at the steel/concrete interface there were no signs of corrosion upon inspection after one year in immersion service.
