Is Plain Water Washing Effective Enough?

Chloride, Sulfate,

and Nitrate Salts on Bridges and Their Removal

By James Johnson,
CHLOR*RID
International, Inc. and
Gary Kowalski,
Illinois Department
of Transportation

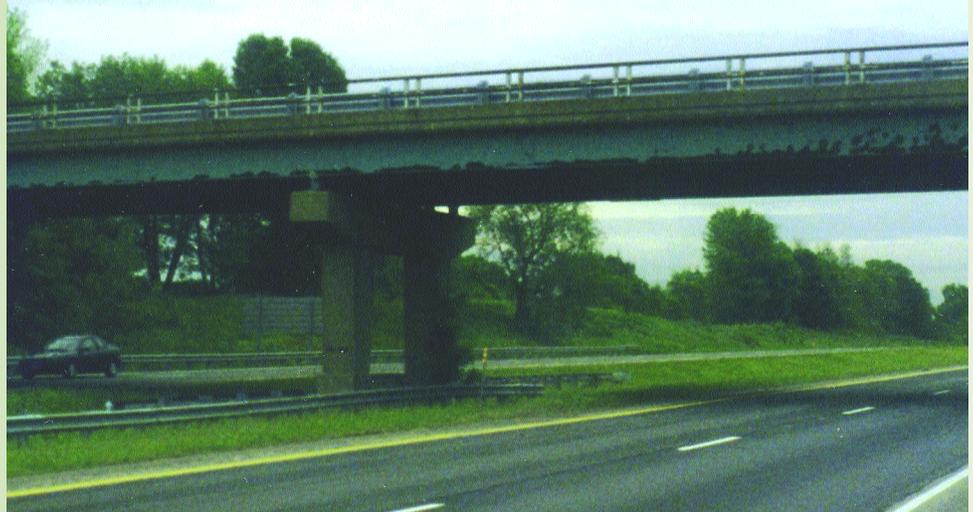
I-270 in Collinsville, IL, one of the bridges in the Illinois Department of Transportation study. Photos courtesy of the authors

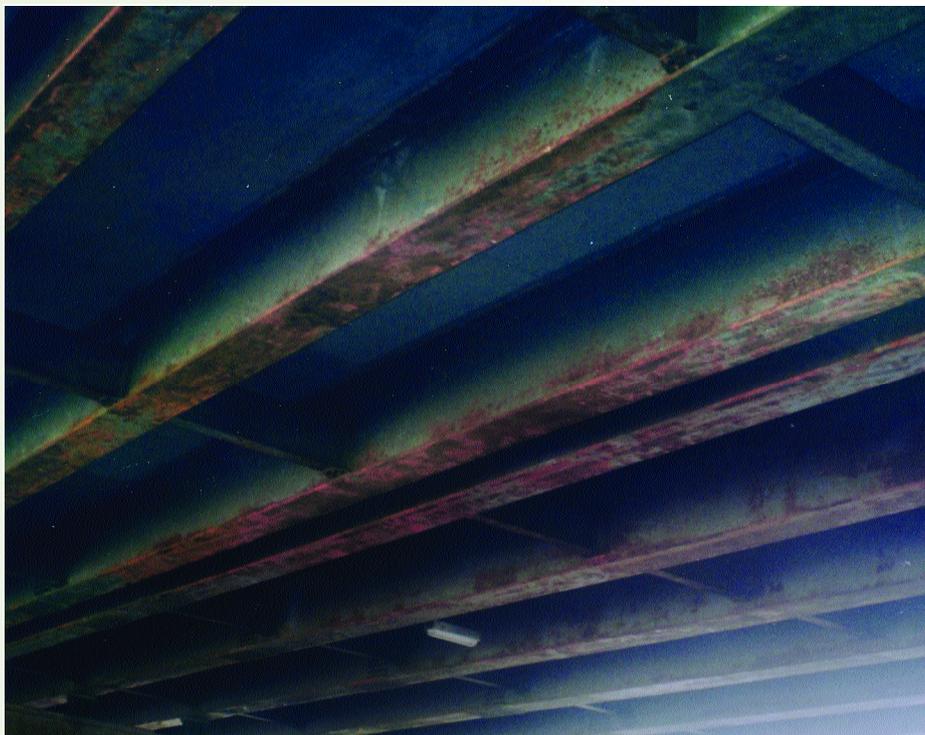
Fig. 1: Deicing salts have run down an open joint on the I-80 bridge, causing corrosion.

Two of the bridges are in District 1 on Interstate-80 in Joliet and required special testing considerations. Interstate-80 at this location is a heavily traveled roadway in an urban environment. The structures are two individual bridges built side by side and to the general public appear as a single bridge. Between the two bridges is an open joint where deicing salts have run down for some time (Fig. 1). The two beams on either side of this joint have suffered heavy corrosion because of the exposure to deicing salts. The water-only wash was performed on the east-bound bridge, and water with the chemical salt remover additive was used on the west-bound bridge. These structures also differed from the others in that there are three lanes under the bridges: an entrance lane, a driving lane, and a passing lane. Sampling was performed over the approximate center of each lane.

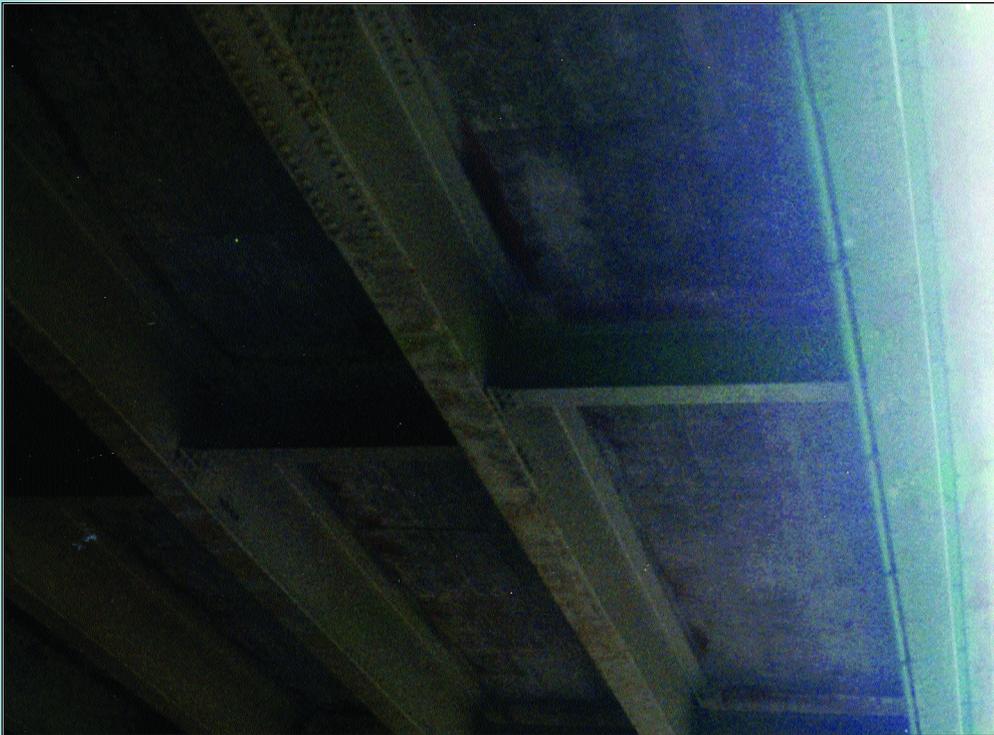
Fig. 3: Corrosion was mainly on the underside of the District 7 bridge on I-57.

These two structures had very little visible corrosion. It was limited to the undersides of the bottom beam flanges (Fig. 3). The contractor set constraints that limited sampling in the passing lane. One would expect the driving
